**Flood Control Project Maintenance
Levee Inspections**

Maintenance Issue Types Only, Levee Inspection Report By Mile - Spring 2018

Reclamation District No. 1602 Del Puerto

Waterway	Bank	Unit Miles	Inspection Start/End	Inspector
Unit No. 01 San Joaquin River	Left	6.24	03/13/2018 03/13/2018	Richard Willoughby

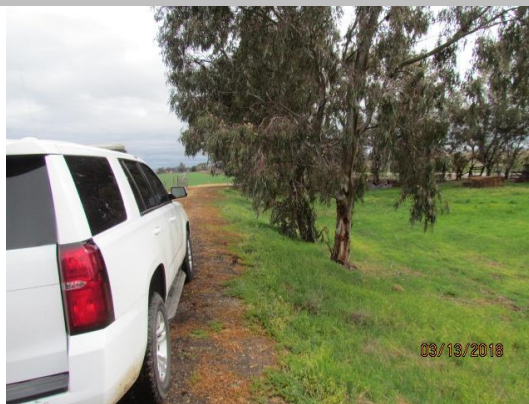
Photo 1 of 1 : SP_2018_RD1602_110_60_20180323_00100.jpg

Looking upstream at trees on landward slope.

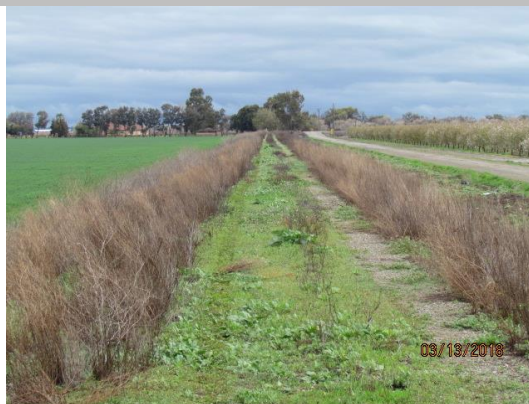
Photo 1 of 1 : SP_2018_RD1602_110_73_20180323_00101.jpg

LM Start	0.13	Rating **	M	Issue No.	73
LM End	6.23	Issue Type +	Ma	Location *	CR
Category	Earthen Levee			GPS Latitude/Longitude	
				Start	End
Item	Crown Surface / Depressions / Rutting			37.477229 °	37.429111 °
				-121.081894 °	-121.029755 °
DWR ID	DWR_RD1602_01_s_2018_73				
Comment Code					
C3 : Add appropriate gravel or road base. Grade and compact.					
Inspector Comment					
Need to control veg. on levee crown and add appropriate gravel

Looking upstream of levee crown.

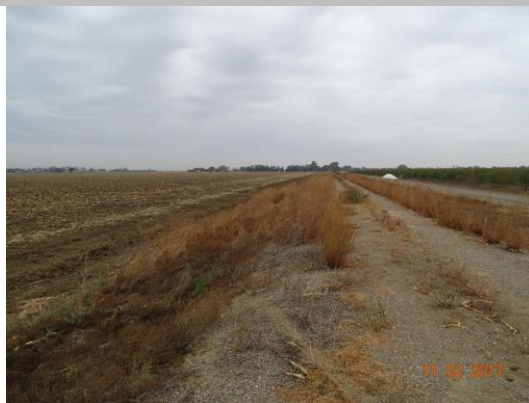
Photo 1 of 1 : SP_2018_RD1602_110_26_20180307_00009.jpg

View of the waterside vegetation. Fall 2017

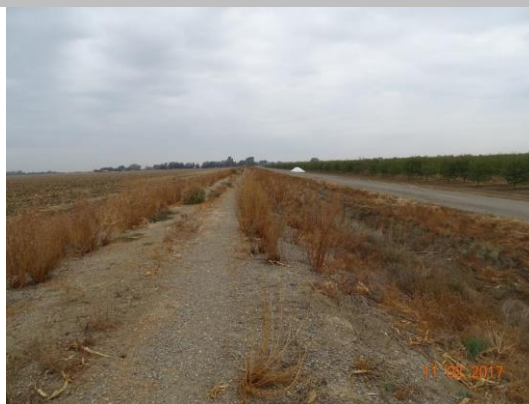
Photo 1 of 1 : SP_2018_RD1602_110_27_20180307_00010.jpg

LM Start	0.14	Rating **	M	Issue No.	27
LM End	1.63	Issue Type +	Ma	Location *	LS
Category	Earthen Levee			GPS Latitude/Longitude	
				Start	End
Item	Vegetation			37.477292 °	37.477499 °
				-121.081613 °	-121.058624 °
DWR ID	DWR_RD1602_01_f_2017_27				
Comment Code					
V1 : Control annual grass and weeds on the levee slopes and easements.					
Inspector Comment

View of the vegetation on the landside of the levee. Fall 2017

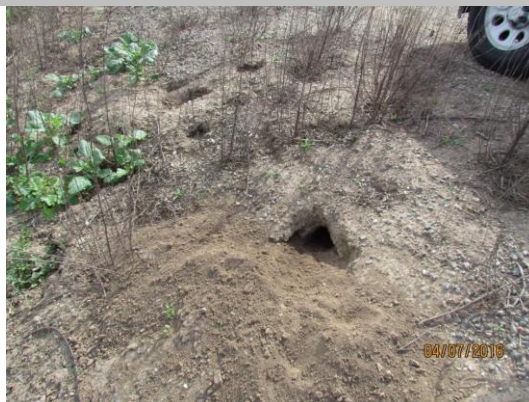
Photo 1 of 2 : SP_2018_RD1602_110_28_20180307_00011.jpg

Updated picture of the rodent hole on the waterside of the levee during spring 2016 inspection.

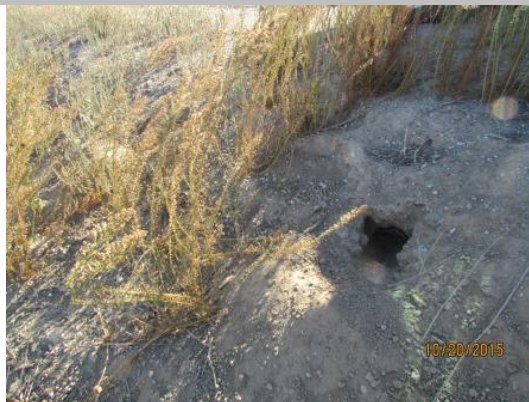
Photo 2 of 2 : SP_2018_RD1602_110_28_20180307_00012.jpg

A rodent hole was found on the waterside of the levee.

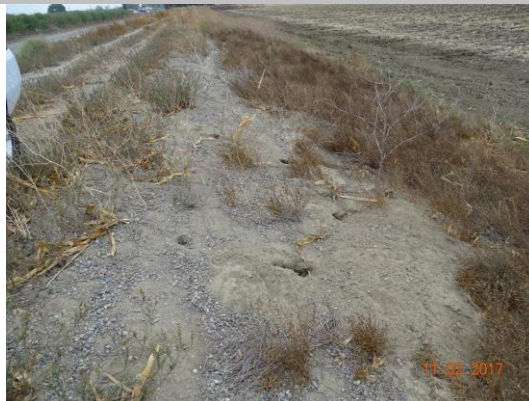
Photo 1 of 2 : SP_2018_RD1602_110_29_20180307_00013.jpg

View of a rodent hole on the waterside of the levee. Fall 2017

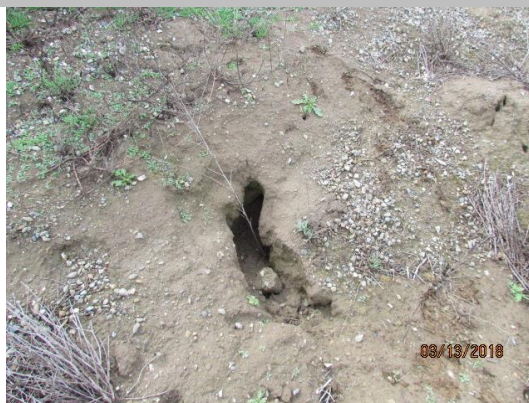
Photo 2 of 2 : SP_2018_RD1602_110_29_20180323_00102.jpg

Looking at typical rodent holes on waterward slope. (Spring 2018)

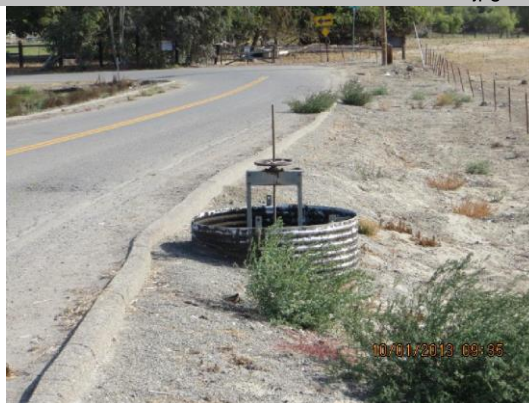
Photo 1 of 3 : UCIP_SP_2018_51325_36702.jpg

FS_ID:51325
DS_ID:20215
EP_NO: N/A
Repair Type: No Action Needed
Crossing Status: Found
UCIP Comments: 11/18/2016 Crossing has been downgraded from Urgent to No Action Needed a cover has been added to the CMP riser. (O. Magana - DWR UCIP)10/01/2013 Open 60-inch CMP riser on WS needs lid as it's depth may be a hazard to the public. (W. Wylie - DWR UCIP)
FIELD_STRUCT_DESC: 16-inch steel drainage pipe through levee, 11.3 feet below crown. Slide gate in 60-inch corrugated metal pipe (CMP) riser located on the waterside (WS). Concrete inlet is approximately 110 feet west of the levee crown or 110 feet off landside (LS) toe next to roadway. [Additional Reference(s): DWR Levee Log, 1992. USACE San Joaquin River O&M Manual Unit 13, April 1964, (HLM 0.58), Drawing No. 7-4-1784].
FS Date: 11/18/2016

60-inch CMP riser on WS shoulder.

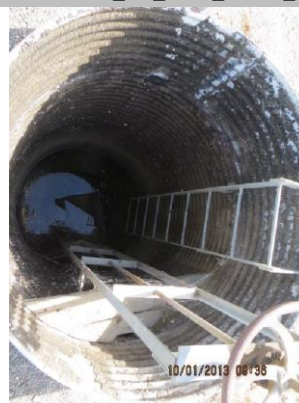
Photo 2 of 3 : UCIP_SP_2018_51325_36701.jpg

CMP riser with slide gate on WS shoulder.

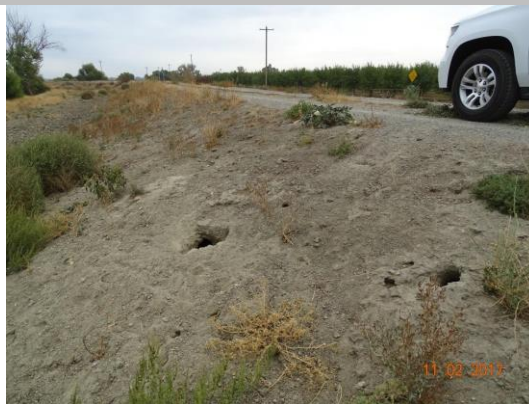
Photo 1 of 1 : SP_2018_RD1602_110_30_20180307_00014.jpg

LM Start	0.64	Rating **	M	Issue No.	30
LM End	0.64	Issue Type +	Ma	Location *	WS
Category	Earthen Levee			GPS Latitude/Longitude	
				Start	End
Item	Animal Control			37.479391 °	37.479391 °
				-121.074168 °	-121.074168 °
DWR ID	DWR_RD1602_01_f_2017_30				
Comment Code					
A3 : No rodents visible, but rodent burrows visible; need to backfill and compact or grout burrows.					
Inspector Comment

View of rodent holes on the waterside slope of the levee. Fall 2017

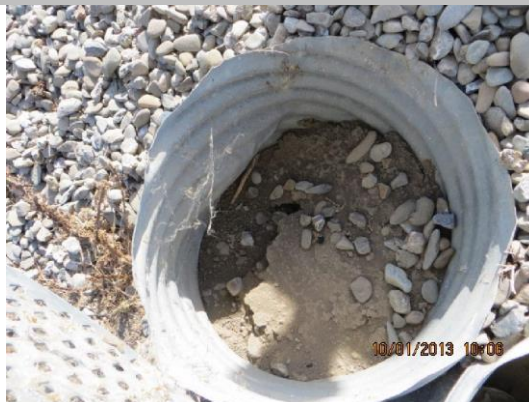
Photo 2 of 3 : UCIP_SP_2018_51637_36771.jpg

Siphon breaker covered in soil at CMP riser on WS shoulder.

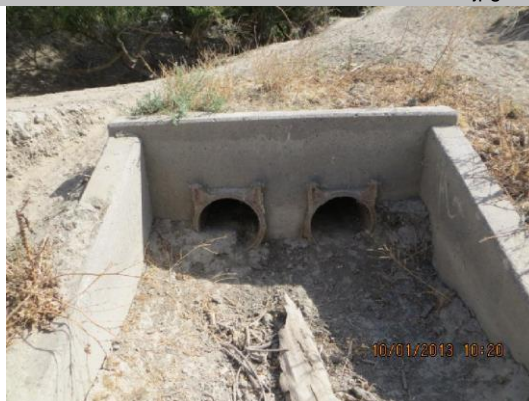
Photo 3 of 3 : UCIP_SP_2018_51637_36770.jpg

Concrete headwall on WS toe with missing flapgate.

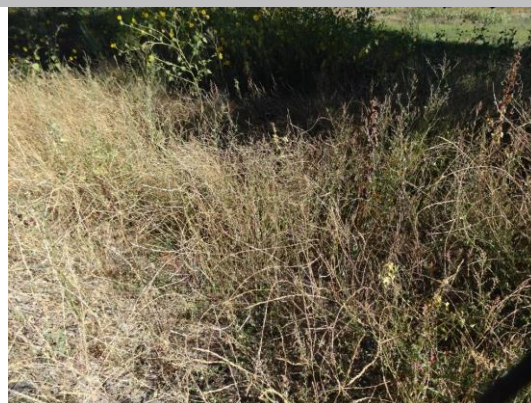
Photo 1 of 4 : SP_2018_RD1602_110_2_20180307_00002.jpg

Close view of the erosion. The erosion is covered by dense vegetation at the site.

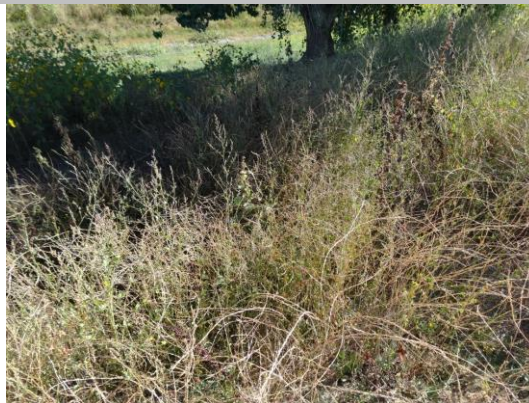
Photo 2 of 4 : SP_2018_RD1602_110_2_20180307_00003.jpg

Close view of the erosion.

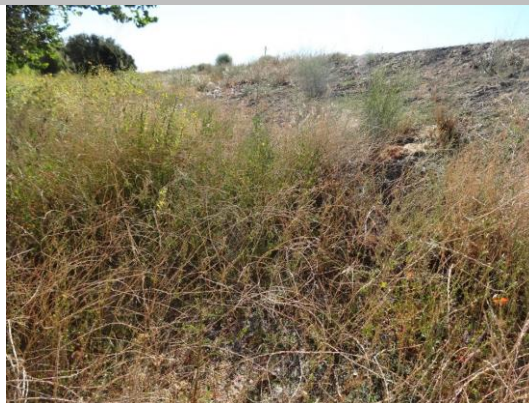
Photo 3 of 4 : SP_2018_RD1602_110_2_20180307_00004.jpg

Looking up at the erosion from the levee toe.

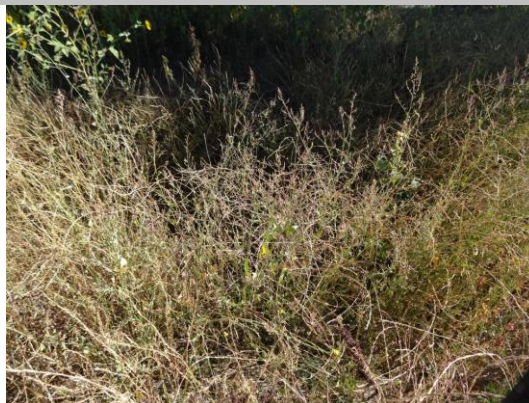
Photo 4 of 4 : SP_2018_RD1602_110_2_20180307_00005.jpg

Close view of the erosion.

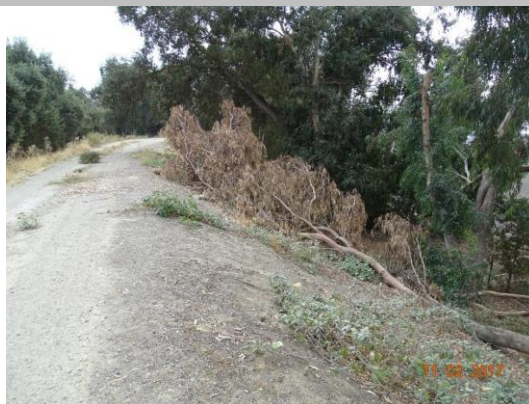
Photo 1 of 1 : SP_2018_RD1602_110_33_20180307_00015.jpg

View of prunings on the landside of the levee.

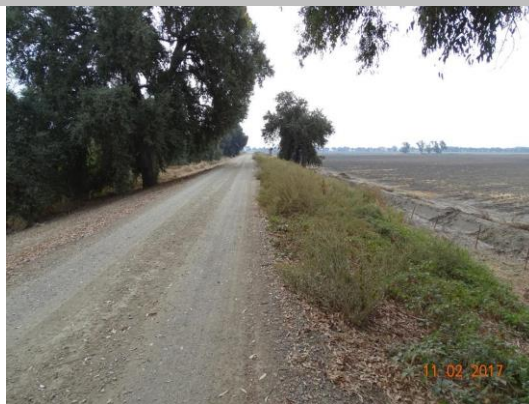
Photo 1 of 1 : SP_2018_RD1602_110_34_20180307_00016.jpg

View of vegetation on the landside of the levee looking upstream. Fall 2017

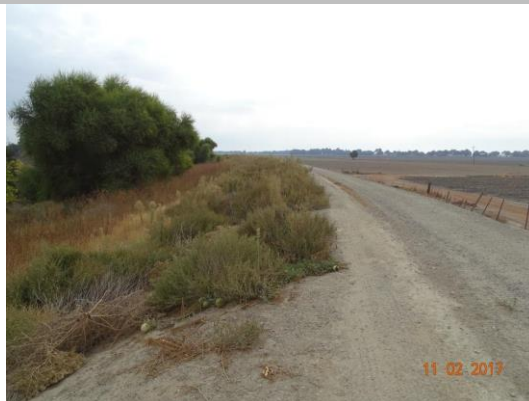
Photo 1 of 1 : SP_2018_RD1602_110_38_20180307_00021.jpg

View of vegetation on the waterside of the levee looking upstream. Fall 2017

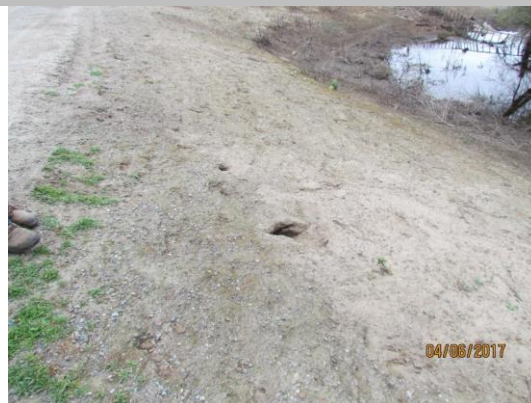
Photo 1 of 1 : SP_2018_RD1602_110_81_20180307_00047.jpg

View of a rodent hole on the waterside slope of the levee.

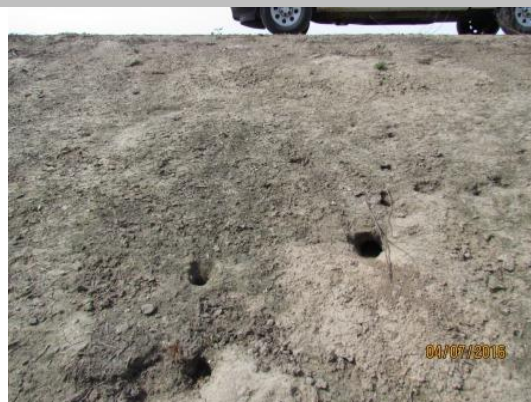
Photo 1 of 1 : SP_2018_RD1602_110_19_20180307_00006.jpg

View of rodent holes on the waterside of the levee.

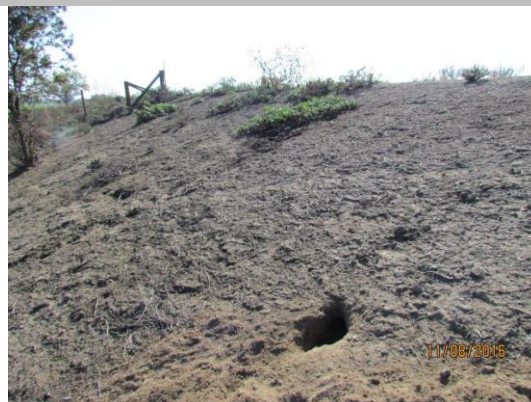
Photo 1 of 1 : SP_2018_RD1602_110_41_20180307_00022.jpg

View of rodent holes on the waterside slope of the levee. Fall 2016

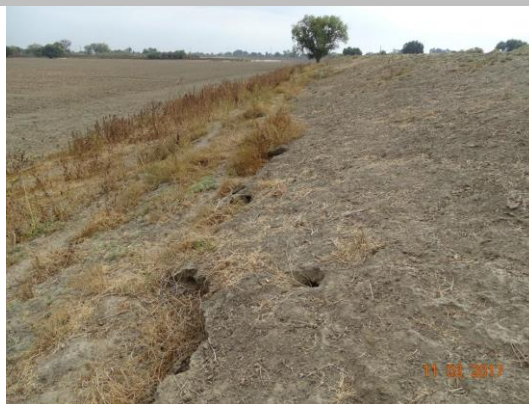
Photo 1 of 1 : SP_2018_RD1602_110_44_20180307_00025.jpg

View of redoent holes on the landside of the levee.

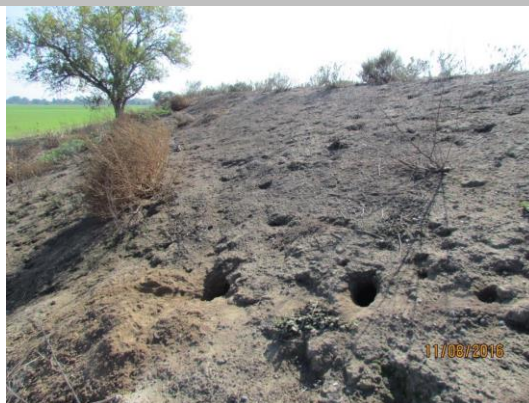
Photo 1 of 1 : SP_2018_RD1602_110_47_20180307_00027.jpg

View of rodent holes on the waterside of the levee. Fall 2016

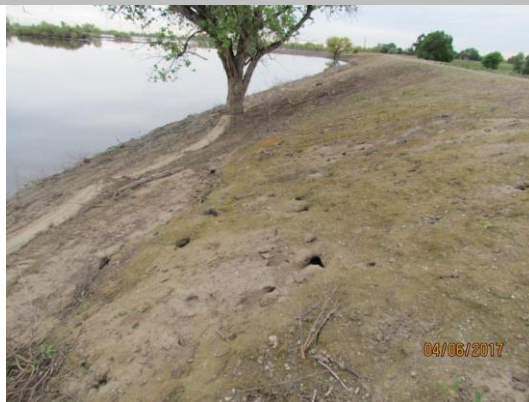
Photo 1 of 1 : SP_2018_RD1602_110_49_20180307_00029.jpg

View of rodent holes on the waterside slope of the levee. Spring 2017

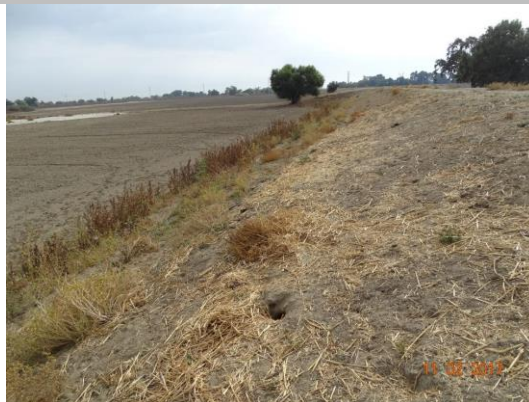
Photo 1 of 1 : SP_2018_RD1602_110_51_20180307_00031.jpg

View of a rodent hole on the waterside of the levee.

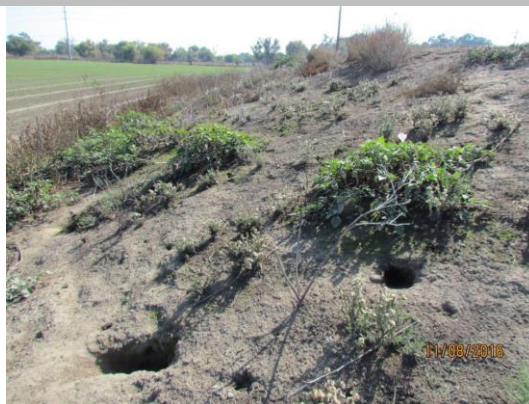
Photo 1 of 1 : SP_2018_RD1602_110_25_20180307_00008.jpg

View of rodent holes on the waterside toe of the levee looking upstream.
Fall 2016

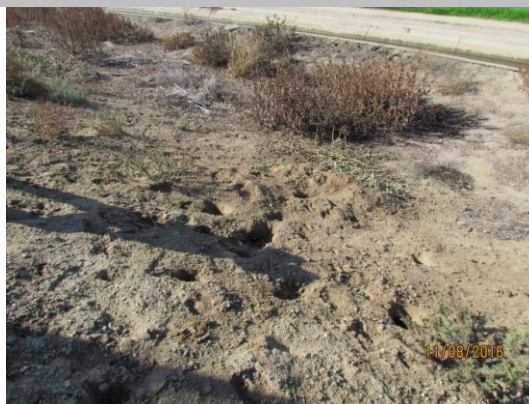
Photo 1 of 1 : SP_2018_RD1602_110_56_20180307_00033.jpg

View of rodent holes on the landside of the levee. Fall 2016

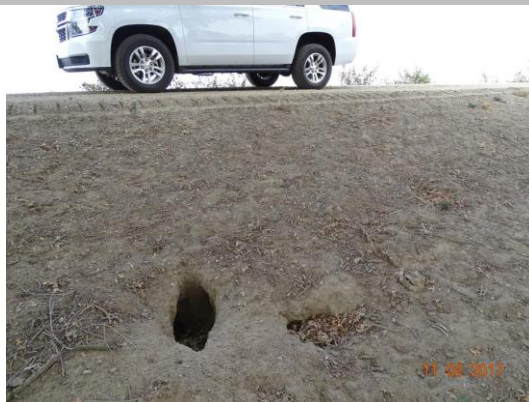
Photo 1 of 1 : SP_2018_RD1602_110_57_20180307_00034.jpg

View of a rodent hole on the waterside of the levee.

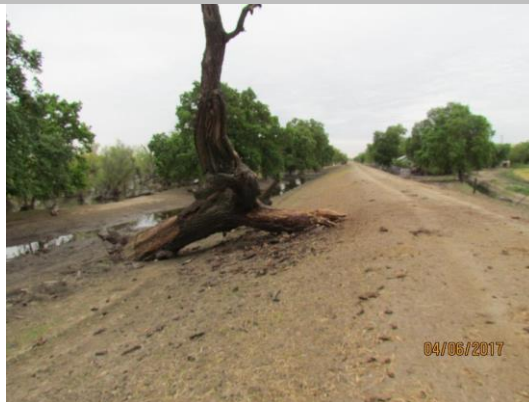
Photo 1 of 1 : SP_2018_RD1602_110_83_20180307_00048.jpg

View of a tree trunk on the waterside slope of the levee.

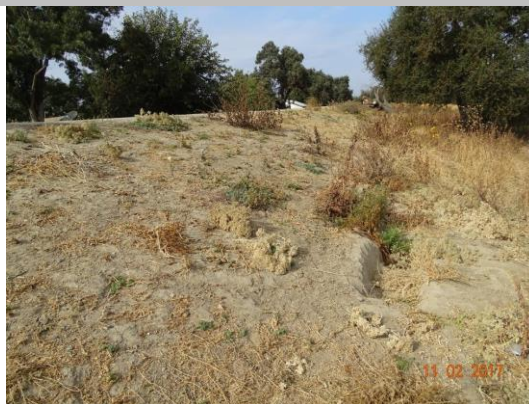
Photo 1 of 1 : SP_2018_RD1602_110_84_20180307_00049.jpg

View of rodent holes on the waterside of the levee.

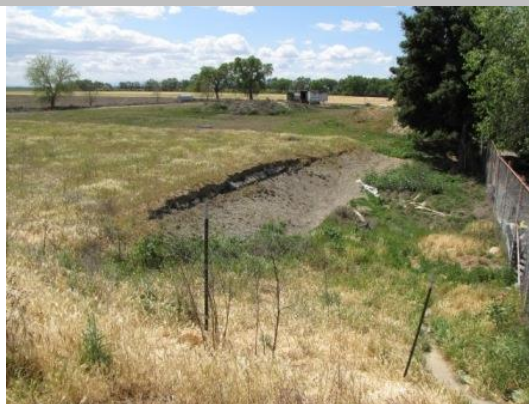
Photo 1 of 1 : SP_2018_RD1602_110_62_20180307_00038.jpg

LM Start	3.93	Rating **	M	Issue No.	62
LM End	3.93	Issue Type +	Ma	Location *	LS
Category	Earthen Levee			GPS Latitude/Longitude	
				Start	End
Item	Slope Stability			37.453216 °	37.453216 °
				-121.042127 °	-121.042127 °
DWR ID	DWR_RD1602_01_s_2012_62				
Comment Code					
S3 : Repair the levee slope damaged by vehicle traffic and prevent access where possible.					
Inspector Comment					
Significant damage to USACE constructed seepage berm due to human activity.

Repair damage to USACE constructed seepage berm by pedestrian and cycle traffic.

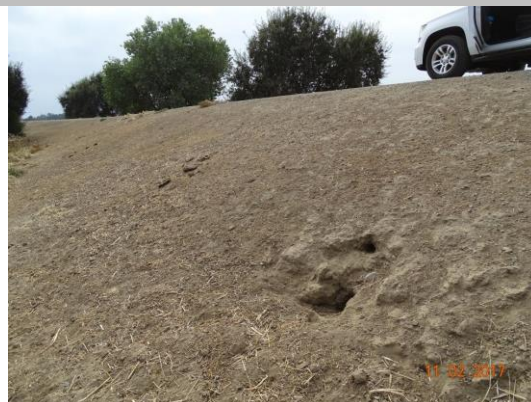
Photo 1 of 1 : SP_2018_RD1602_110_58_20180307_00035.jpg

View of rodent holes on the waterside of the levee.

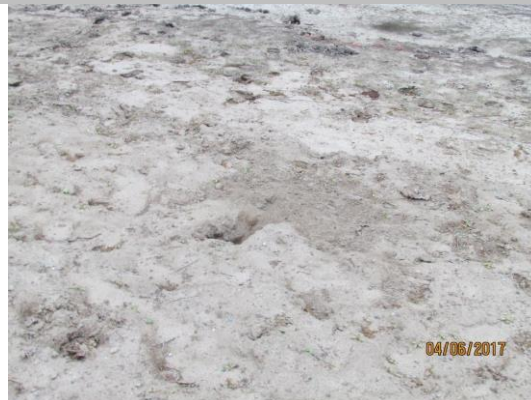
Photo 1 of 1 : SP_2018_RD1602_110_88_20180307_00050.jpg

View of a rodent hole on the waterside slope of the levee.

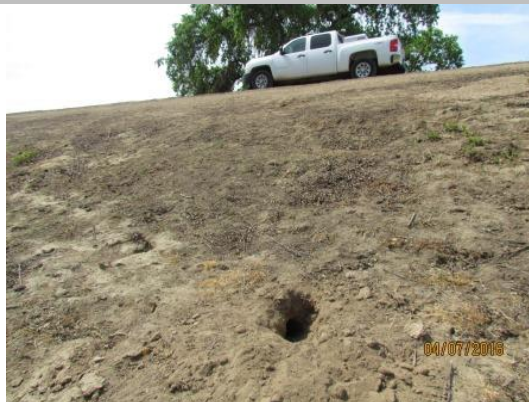
Photo 1 of 1 : SP_2018_RD1602_110_74_20180307_00045.jpg

View of a rodent hole on the waterside toe of the levee.

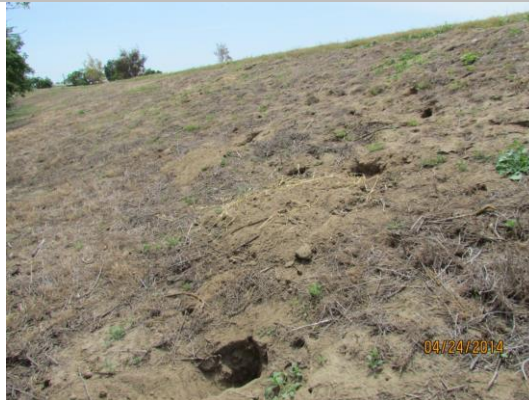
Photo 1 of 1 : SP_2018_RD1602_110_199_20180307_00053.jpg

Rodent holes were found on the waterside toe of the levee looking upstream.

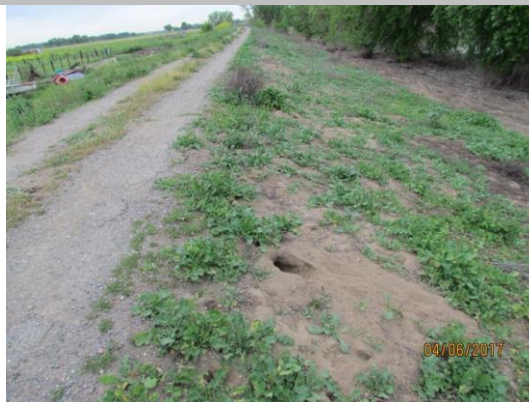
Photo 1 of 1 : SP_2018_RD1602_110_92_20180307_00052.jpg

View of a rodent hole on the waterside shoulder of the levee looking downstream.

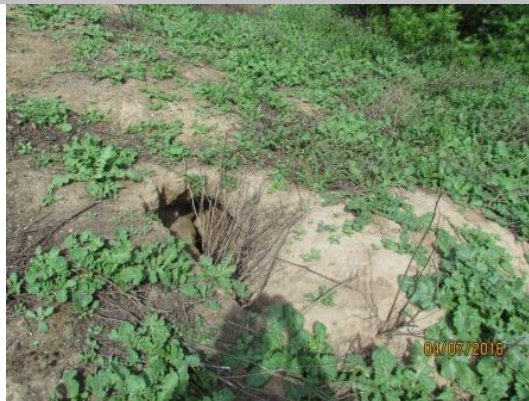
Photo 1 of 1 : SP_2018_RD1602_110_48_20180307_00028.jpg

View of rodent holes on the waterside of the levee looking downstream.

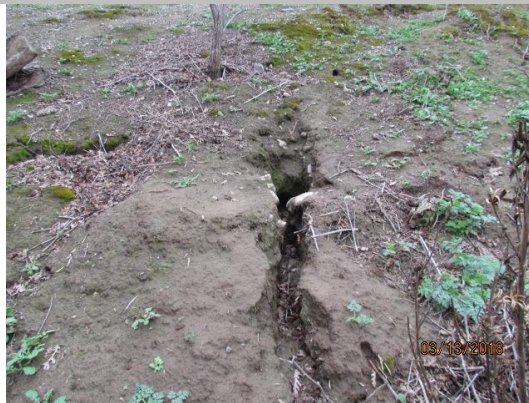
Photo 1 of 1 : SP_2018_RD1602_110_52_20180323_00108.jpg

Looking at rodent hole and erosion around rodent hole on waterward slope.

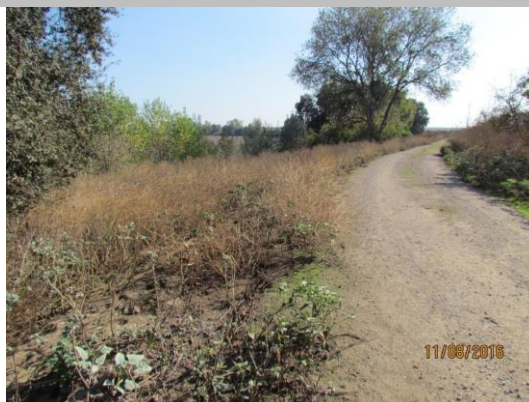
Photo 1 of 2 : SP_2018_RD1602_110_75_20180307_00046.jpg

Vegetation was found on the waterside slope of the levee looking upstream during fall 2016 inspection.

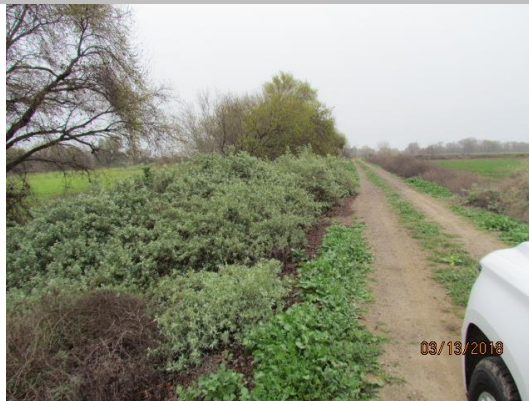
Photo 2 of 2 : SP_2018_RD1602_110_75_20180323_00112.jpg

Looking at upstream at dense vegetation on waterward slope. (Spring 2018)

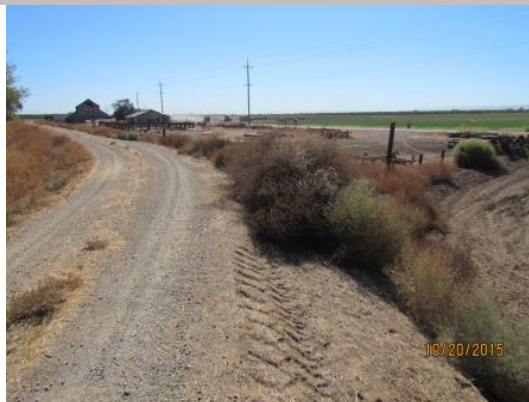
Photo 1 of 1 : SP_2018_RD1602_110_61_20180307_00037.jpg

Vegetation was obstructing the view of the landside of the levee.

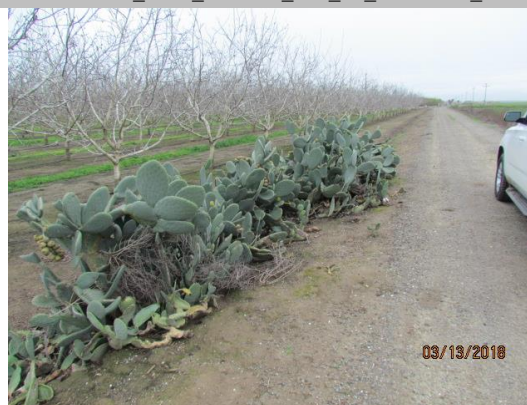
Photo 1 of 1 : SP_2018_RD1602_110_86_20180323_00113.jpg

Looking south at dense cactus on waterward slope.
